Zackuse Erosion ELSP Photos 031416

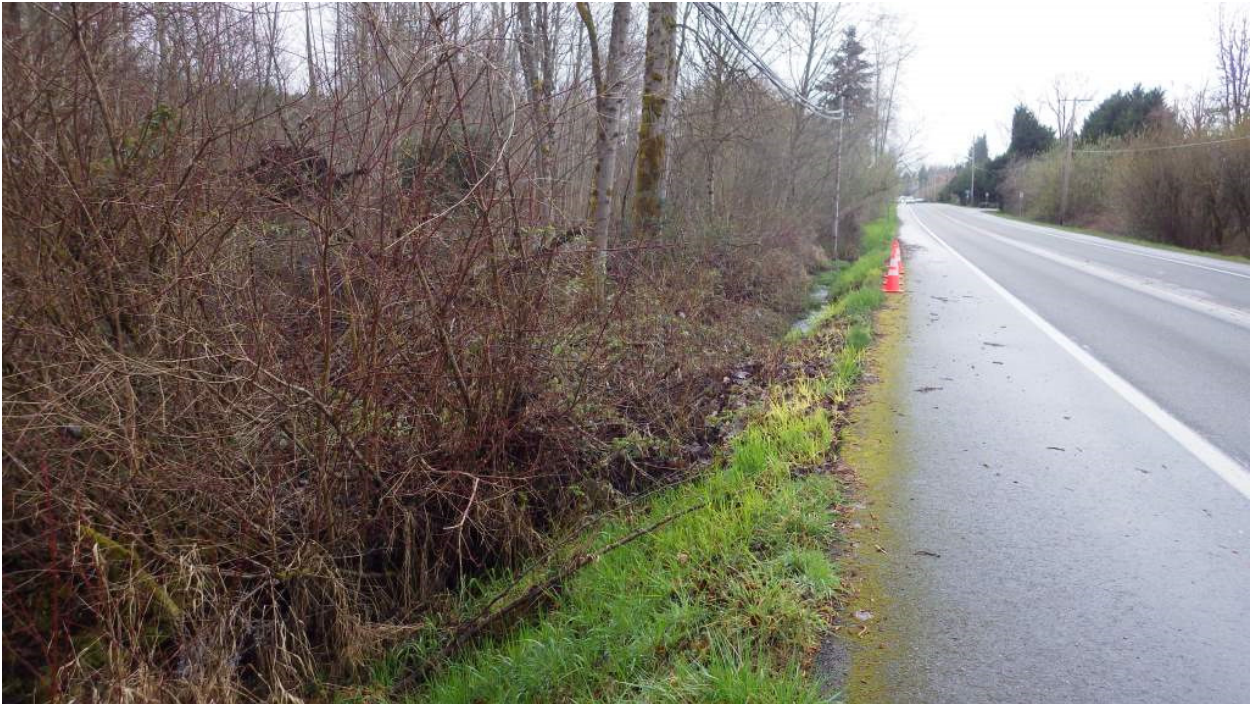
Zackuse Creek looking upstream (south on East Lake Sammamish Parkway;ELSP)

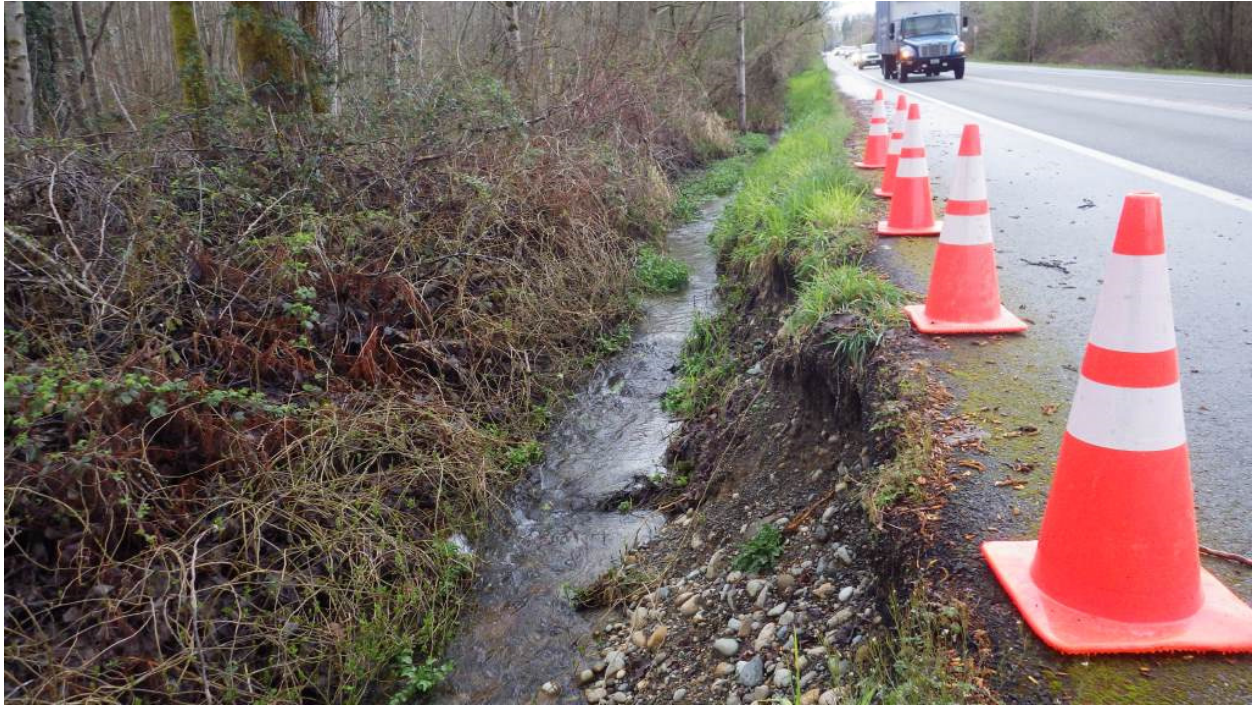
Erosion is occurring along approximately 30 feet of the stream channel.

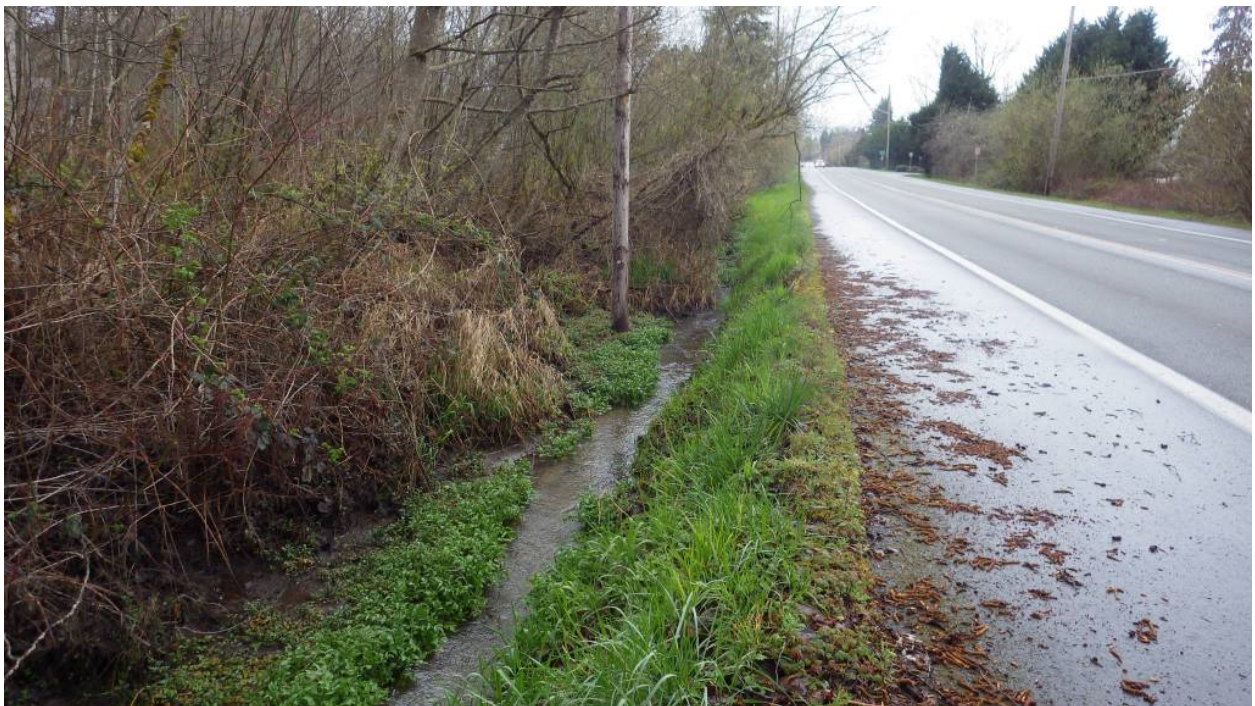
oversteepened bank extends upstream

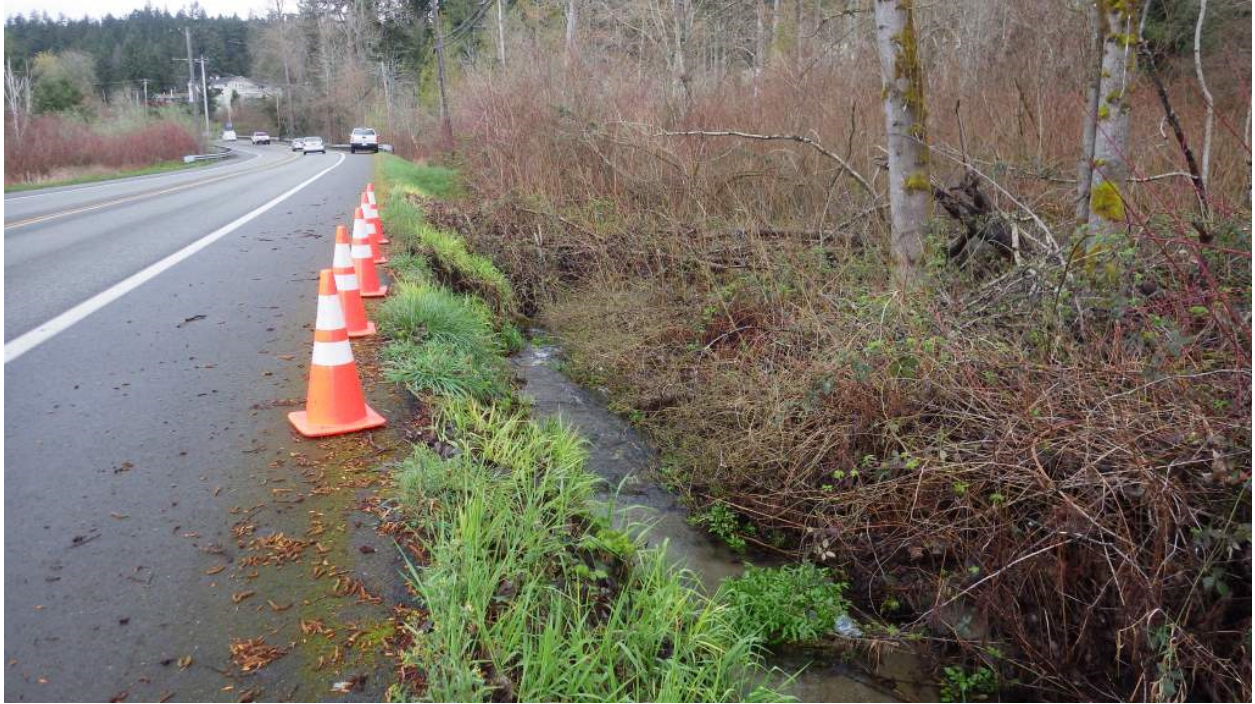
looking downstream towards ELSP culvert entrance (stream turns 90 degrees left/west)

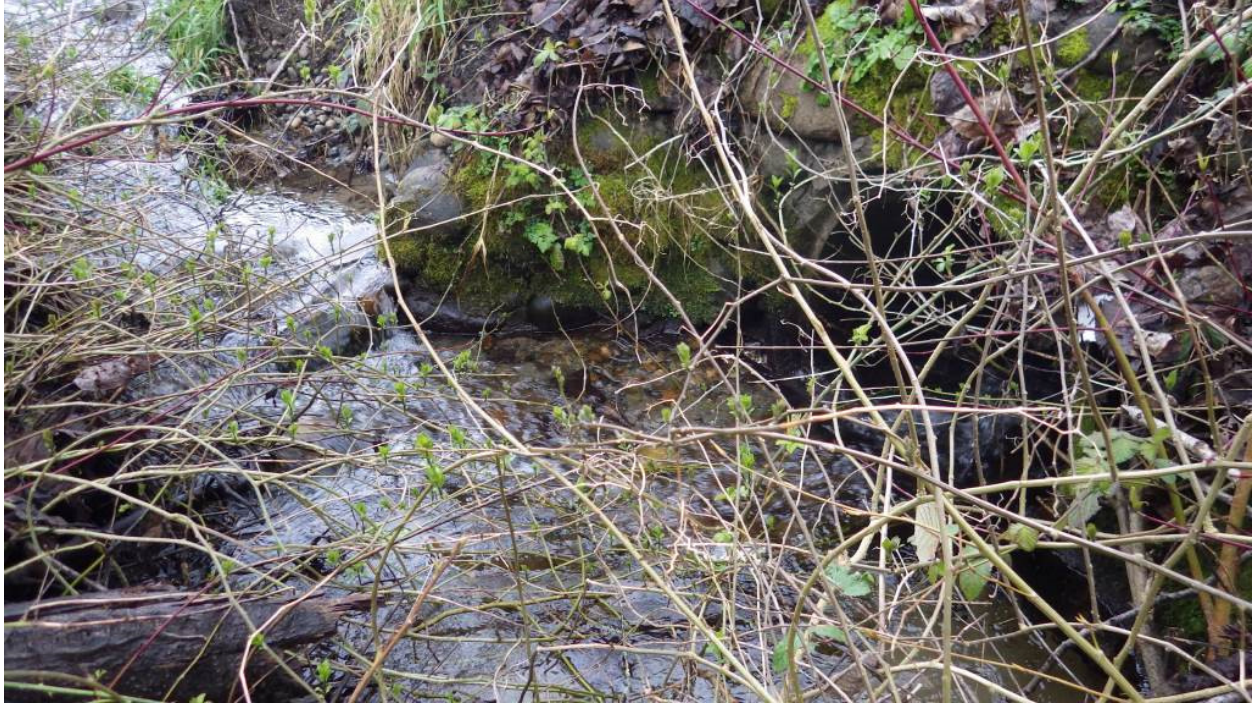
culvert inlet (30 inch concrete) under ELSP; identified as a partial barrier by WDFW; site ID 920253

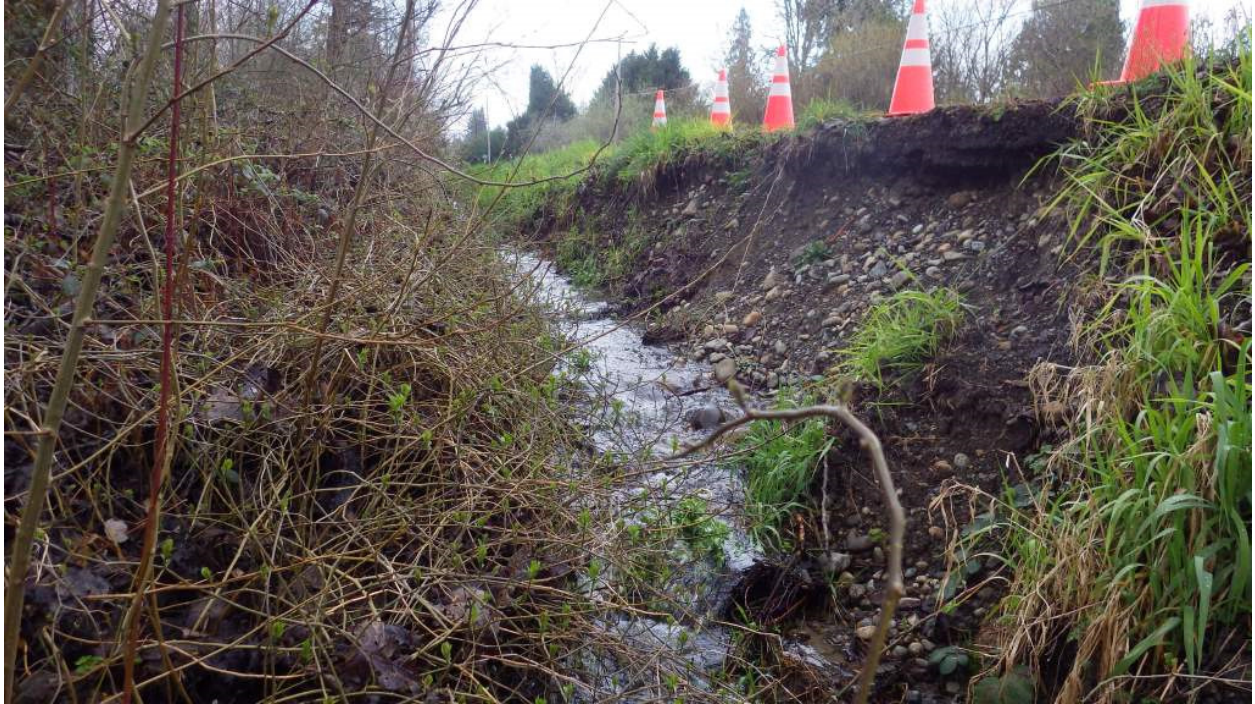
erosion is approximately 6 feet upstream from culvert entrance

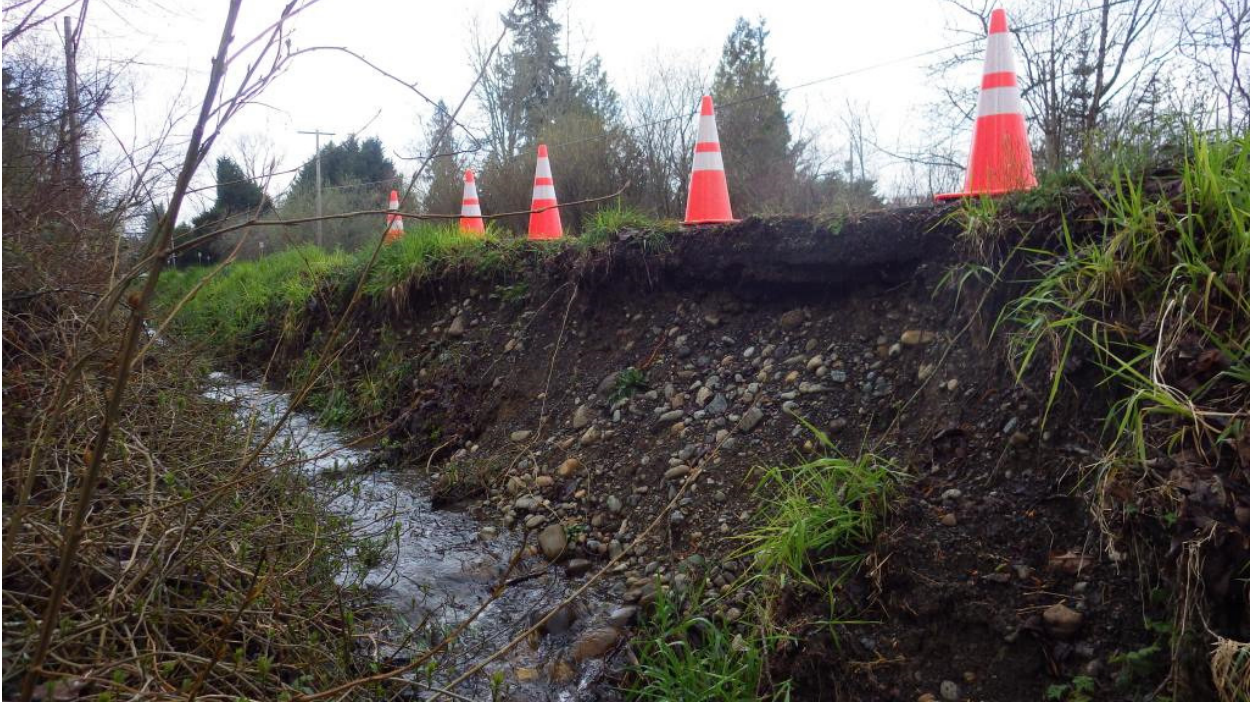
approximately 7 feet of asphalt is exposed; maximum undermine in center is 6 inches

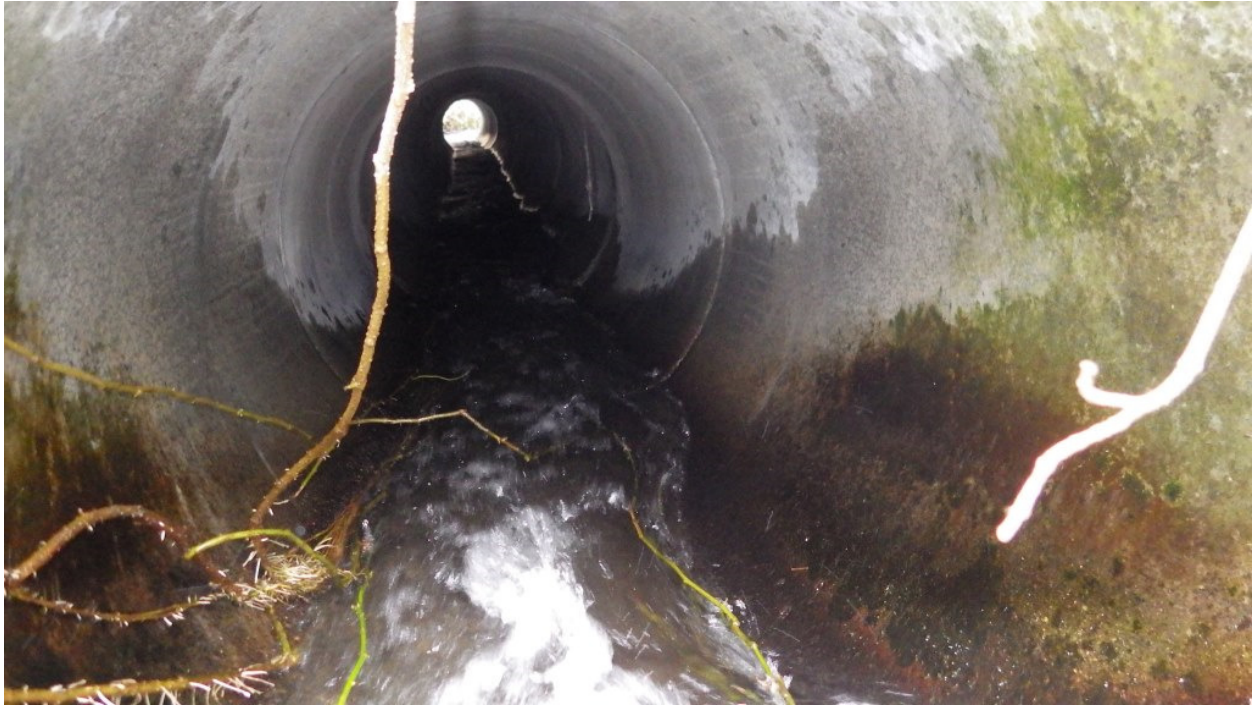
culvert lacks substrate

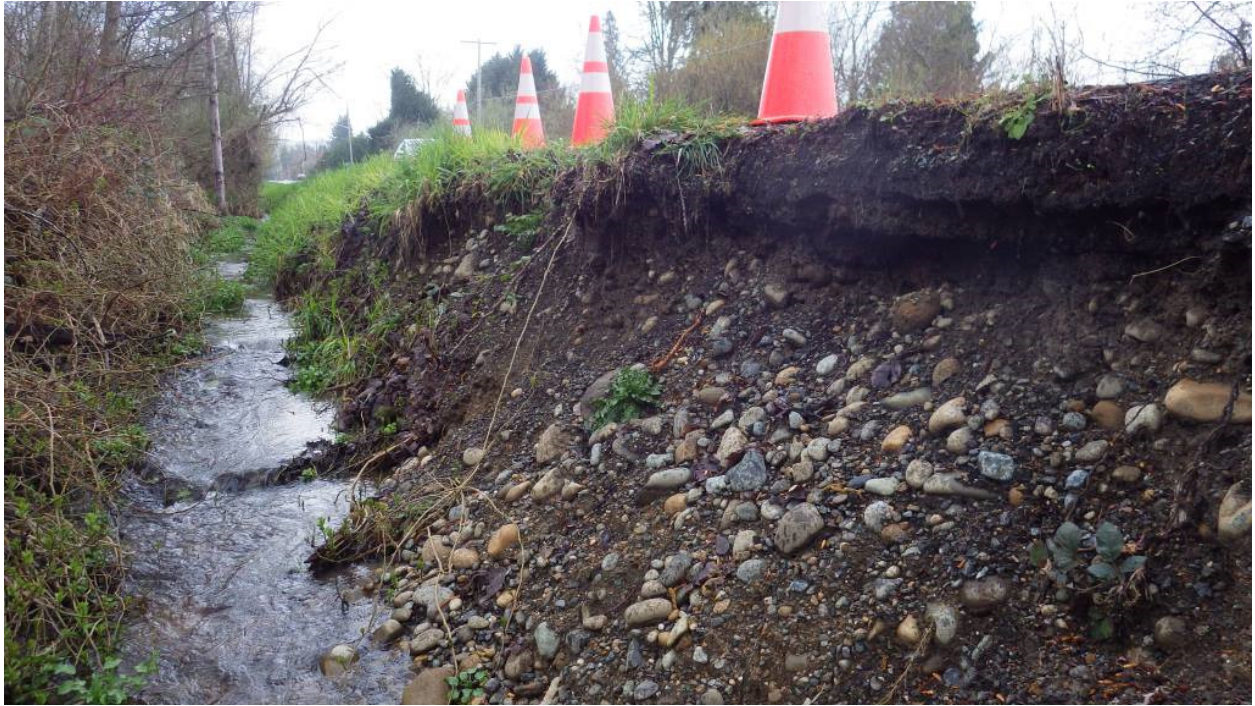
channel was approx. 6 ft wide with 5 feet wetted (BFW 7 ft downstream), approx. 3% slope

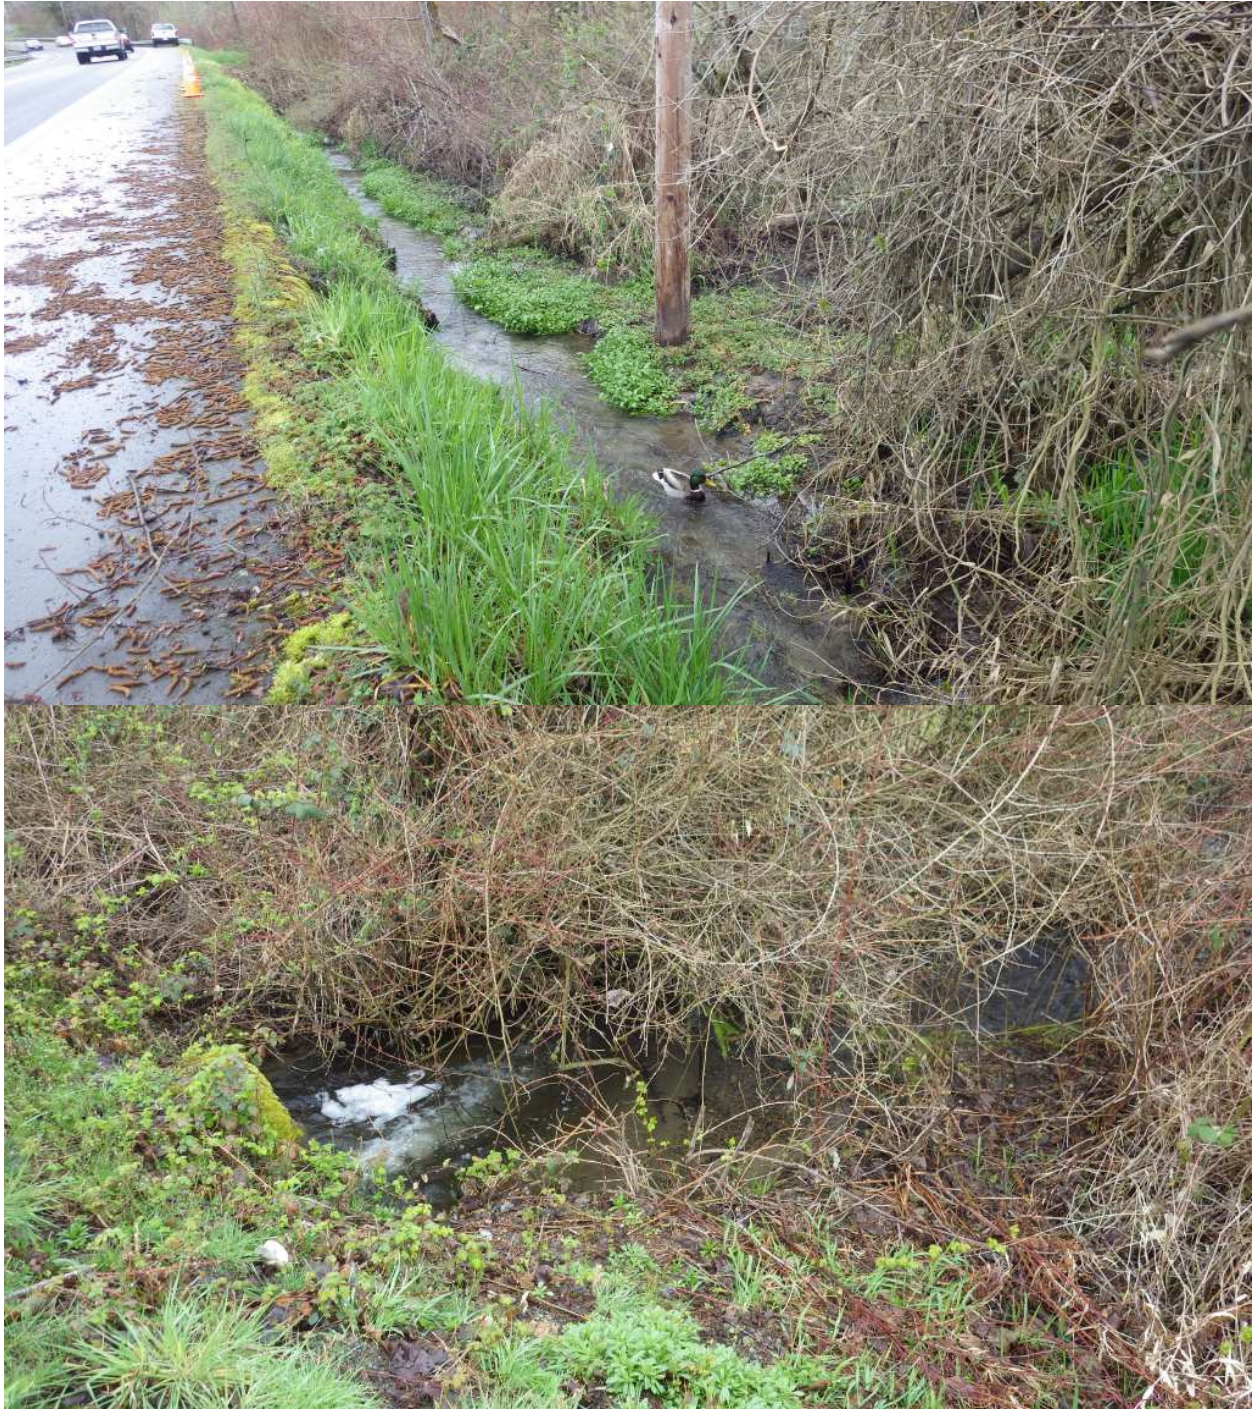
culvert downstream of ELSP
